**DEPARTMENT OF TRANSPORTATION**

OBG Seg 9DW and Seg 9EW:

## WELDING INSPECTION REPORT

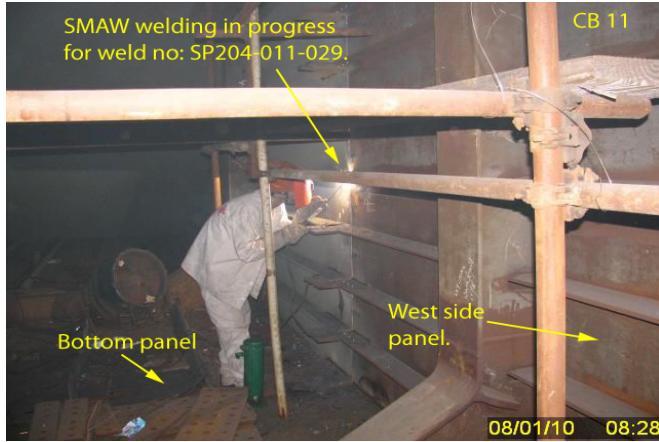
Cross Beam 11 (CB11):

The SMAW process on weld joint no's: SP204-011-025, 027 and 029. The welder was identified as 069841 and was observed welding in the 4F position. ZPMC QC was identified as Xu Jin Long. The welding variables recorded by QC appeared to comply with WPS: B-P-2114-FCM-1. See attached photo for further details.
